①
UH-1-91-ASAM-03
improved particle
separator

SUBJECT - AVIATION SAFETY ACTION MESSAGE, INFORMATIONAL. RCS
CSGLD-1860(R1), ALL UH-1H/V HELICOPTERS, ADVANCE NOTICE OF MANUAL
CHANGES CONCERNING THE IMPROVED INLET PARTICLE SEPARATOR (IPS),
(UH-1-91-ASAM-03)

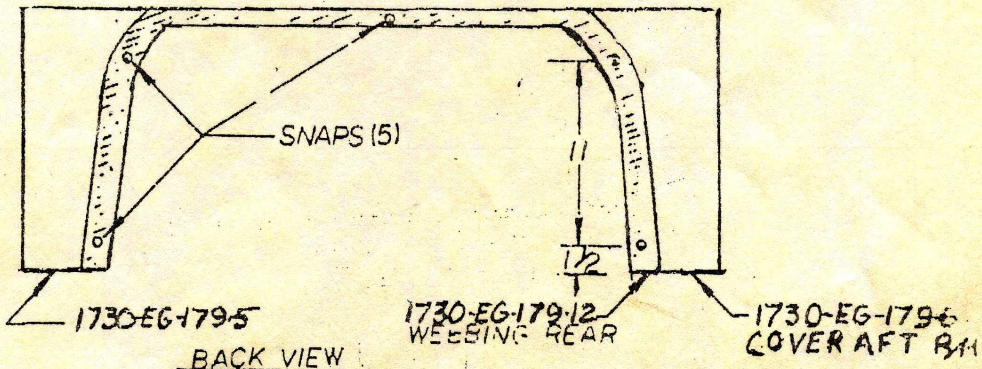
BACK VIEW

SNAPS (5)

1730-EG-179-5

1730-EG-179-12
WEBBING REAR

1730-EG-179-6
COVER AFT RM

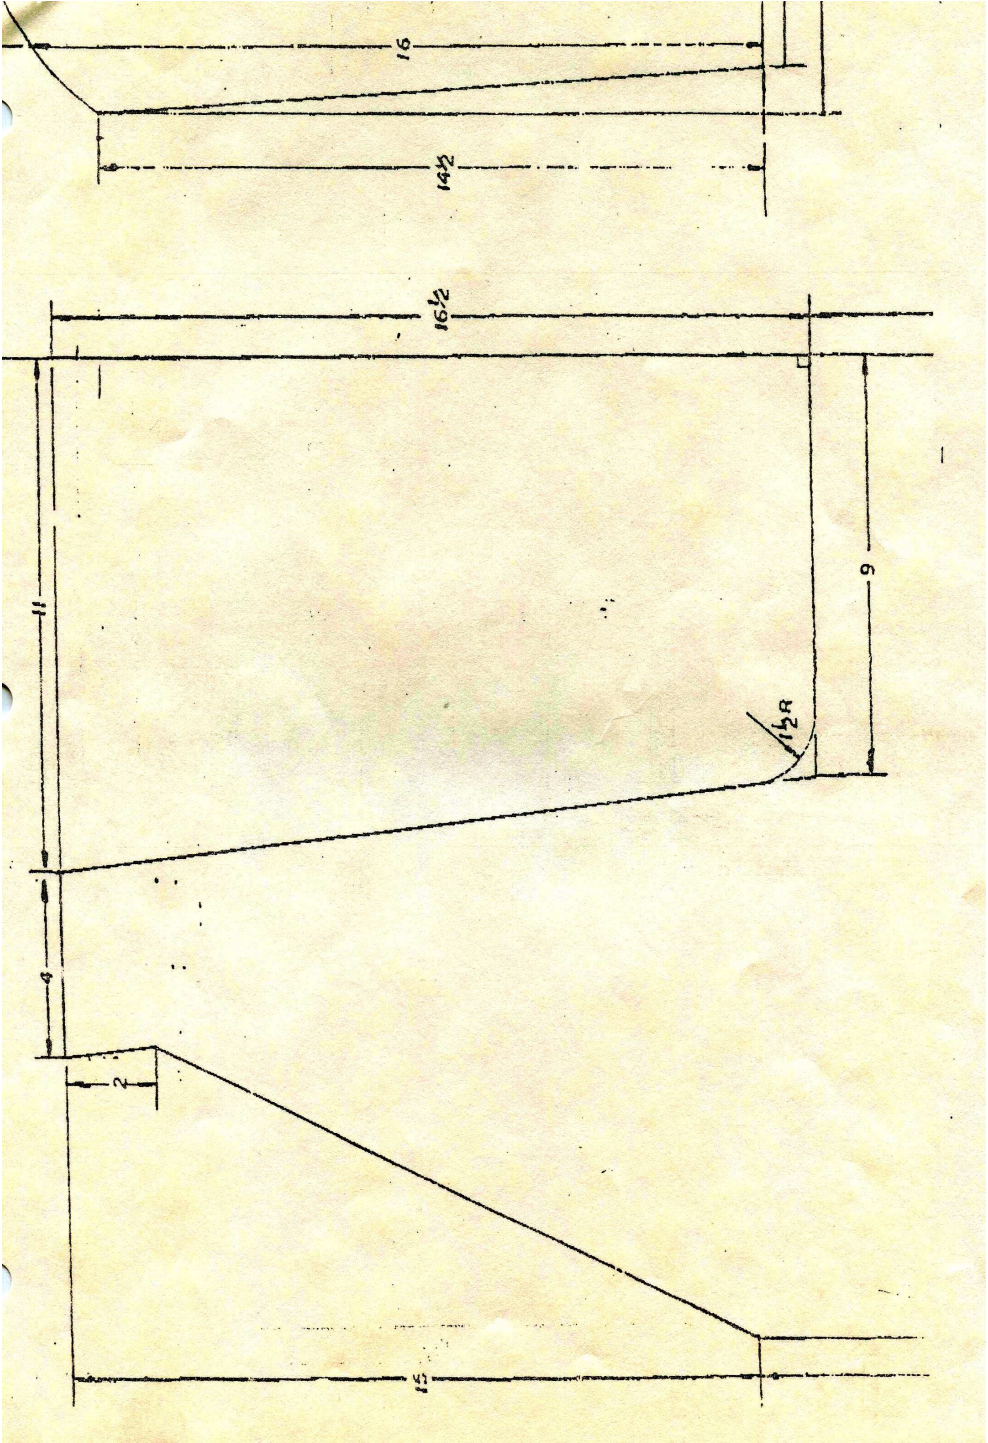
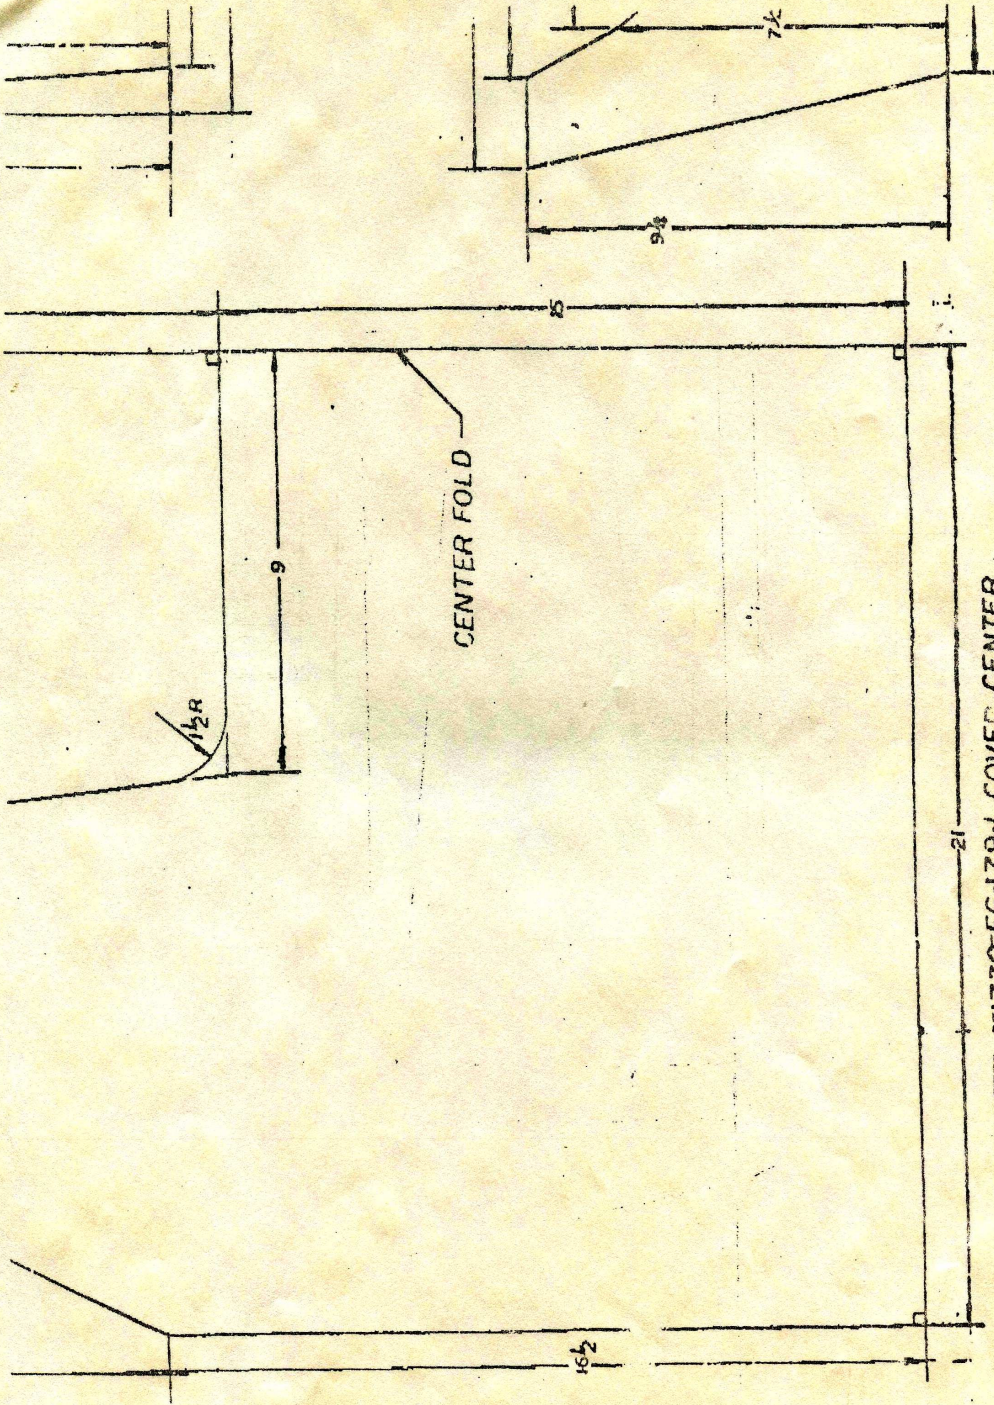
1730-EG-179-1 COVER CENTER CENTER
 PART IS SYMMETRICAL ABOUT CENTERFOLD
 1/4 DIMENSIONS (SHM)

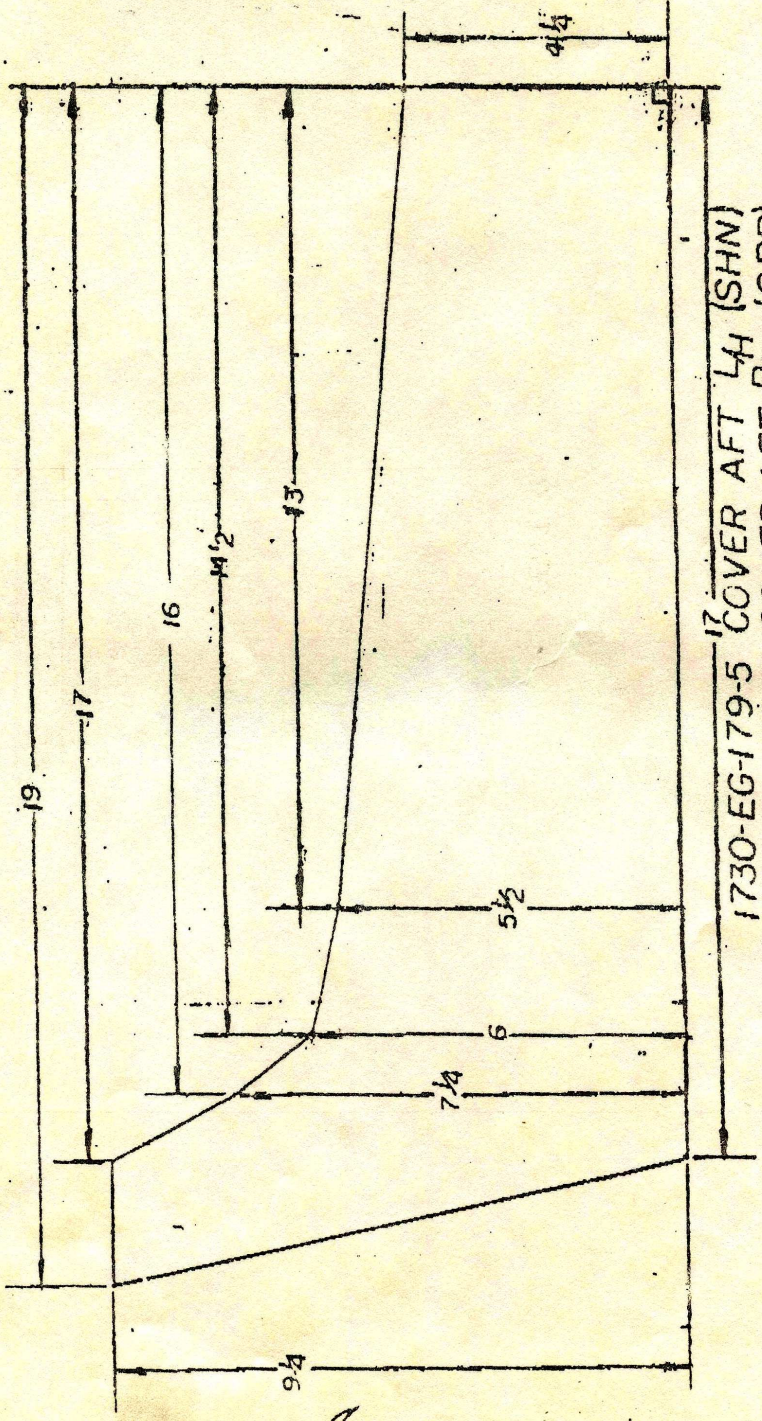
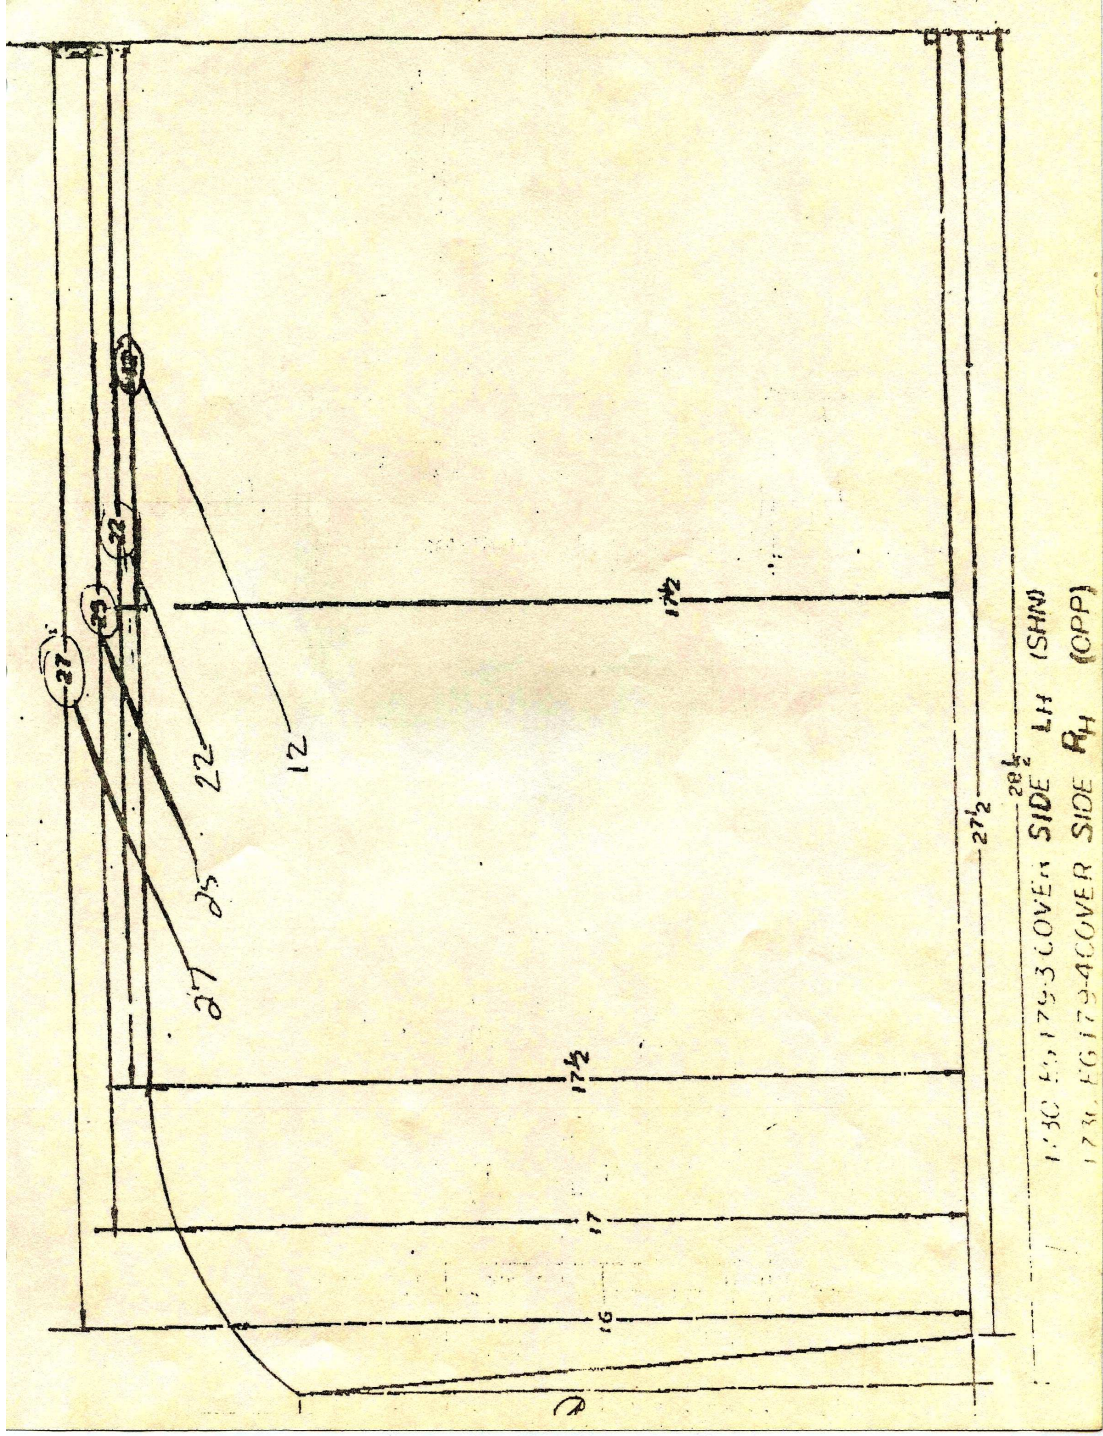
1730-EG-179-5 COVER AFT LH (SHN)
 1730 EG 179 6 COVER AFT RH (OPP)

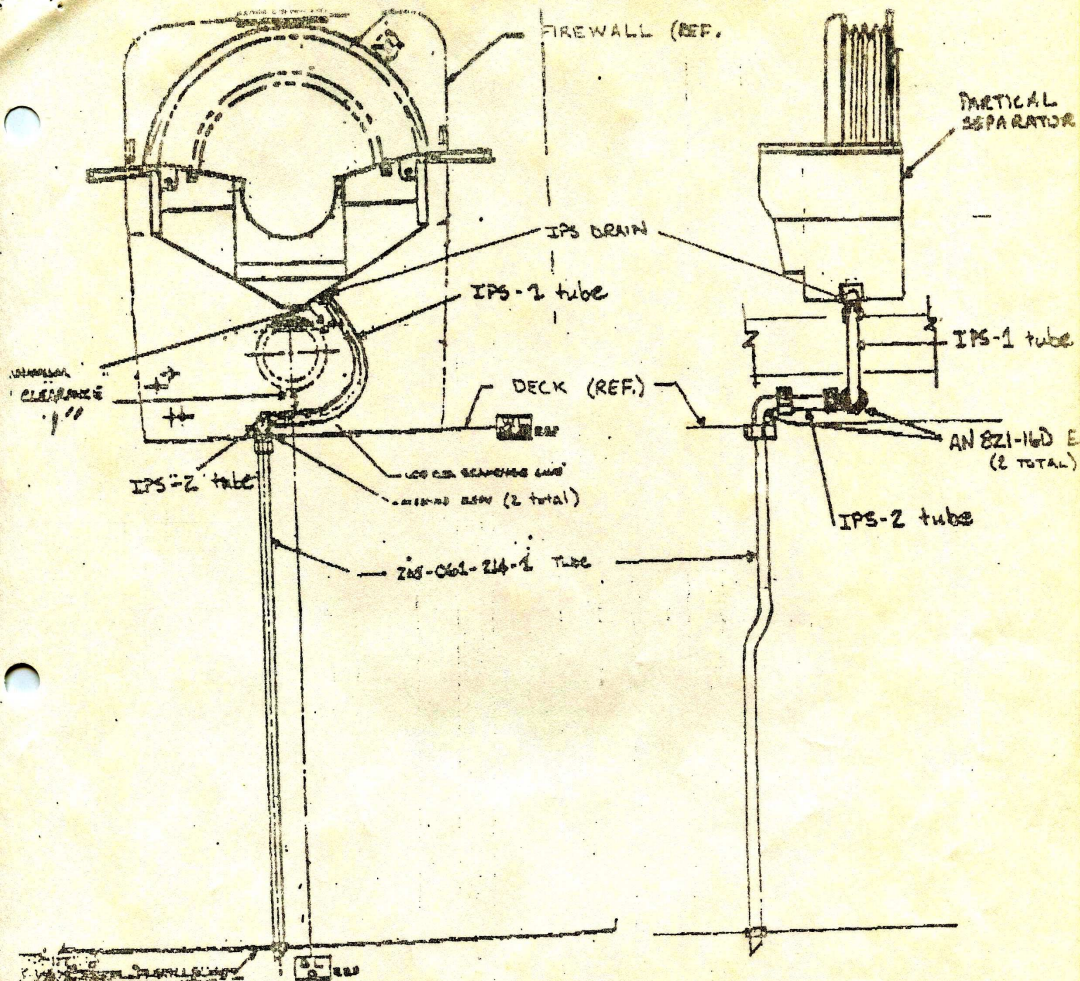
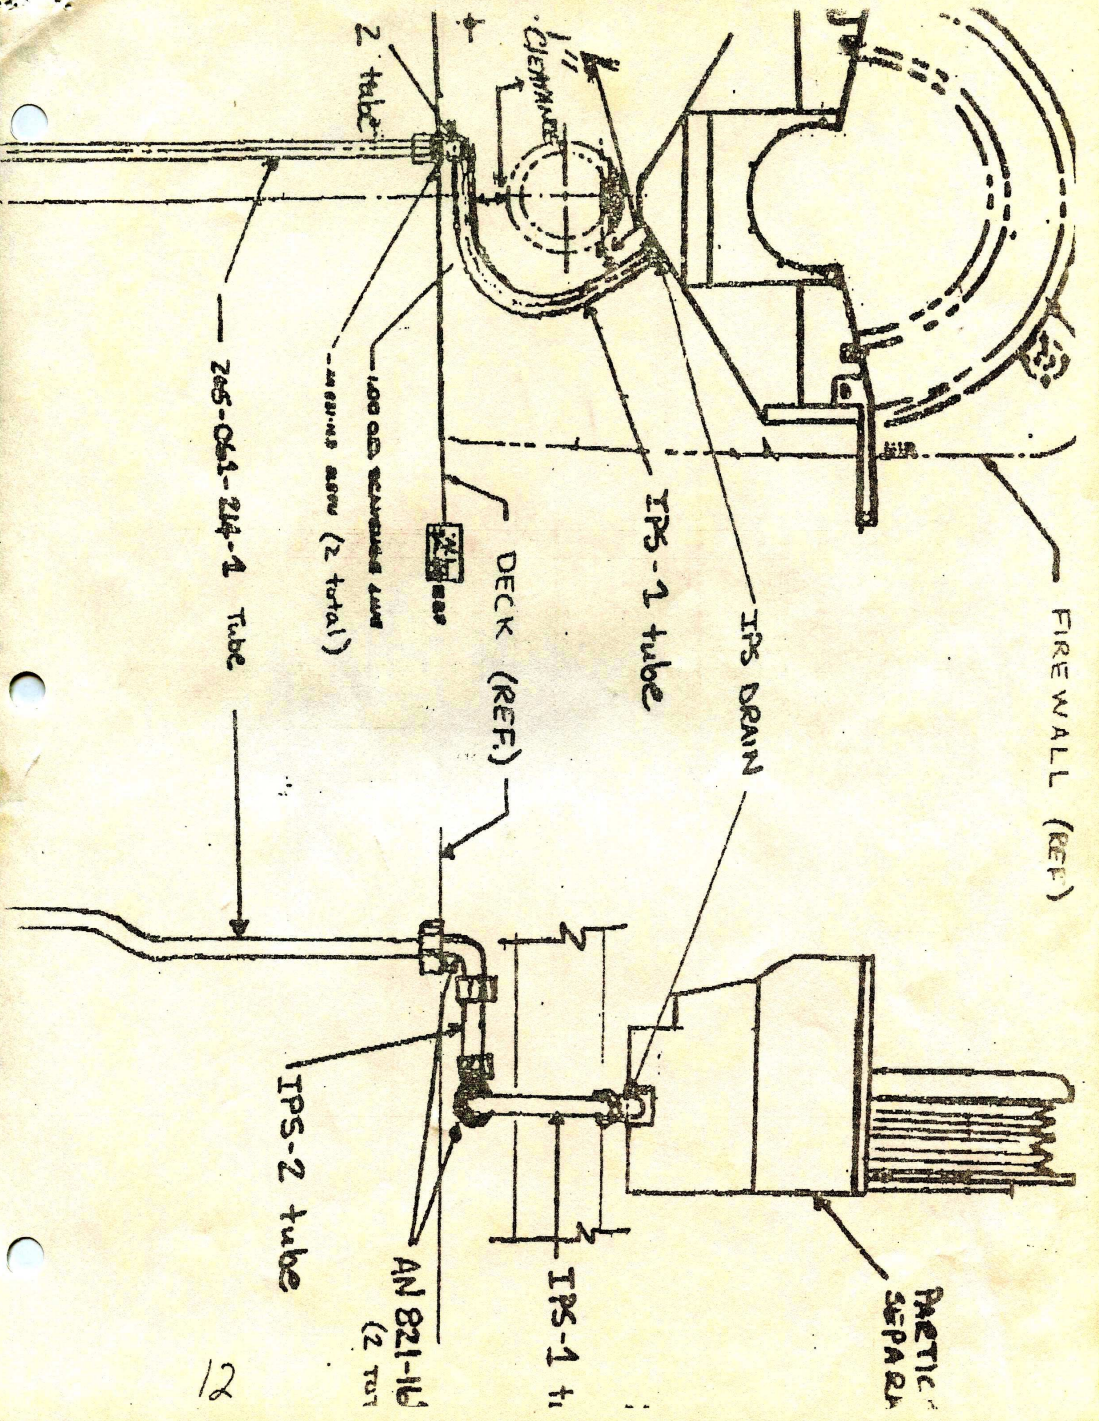
IPS DRAIN TUBE ASSY.

PART NUMBER	END WT	DIMENSION "A"		END RADIUS TYPE END "Y"	DIAL SETTING TYPE END "X"		BEND ANGLE PRESSURE TEST	END FITTING AND NOTES
		FROM "Y" END DIMENSION "B"	"B"		TYPE END "X"	"X"		
208-081-214-1 (Banning drain track)	1	3	3	3	0	40		Y - AN818-18D
	1	3	3	3	150	10		MS20318-19D
	1	3	3	3	V	N/A		X - Start Dial Setting 140
IPS-1	1	1.75	3	0	0	110		
IPS-2	N/A	STRAIGHT TUBE			SEE BELOW

PART NUMBER	BEND NO.	DIMENSION "A" FROM "Y" END DIMENSION "B"	BEND RADIUS TYPE END "Y"	DIAL SETTING TYPE END "X"	BEND ANGLE PRESSURE TEST	END FITTING AND NOTES			
							STOCK DIM. L	END-FITTING QTY	SYSTEM
TUBE ASSY PART NO.	FABRICATE FROM NSN	OD	WT.	L	NUT NSN	QTY	SLEEVE NSN	QTY	SYSTEM
206-081-214-1 (Existing drain tube)	1		21	3	0	40	Y - ANS18-18D MS20819-18D X - Scrf Dial Setting 140		
	2		25 1/4	3	180	30			
			49	1	V	N/A			
IPS-1	1	1.75		3	0	110			
IPF-2	N/A	STRAIGHT TUBE SEE BELOW							
206-081-214-1	4710-00-278-8723	1.	.035	51	4730-00-222-1915	1	4730-00-287-0085	1	Drain
IPS-1	4710-00-278-8723	1	.035	10.5	4730-00-222-1915	2	4730-00-287-0085	2	Drain
IPS-2	4710-00-278-8723	1	.035	31.25	4730-00-222-1915	2	4730-00-287-0085	2	Drain
