TO: All owners and operators of Bell Helicopters

SUBJECT: TORQUE APPLICATION ON FLUID LINES AND FITTINGS

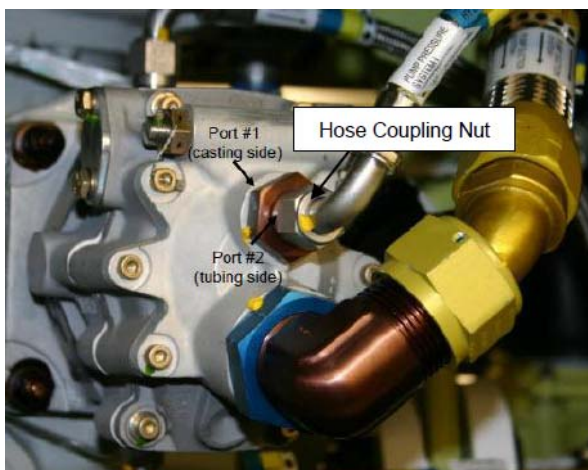
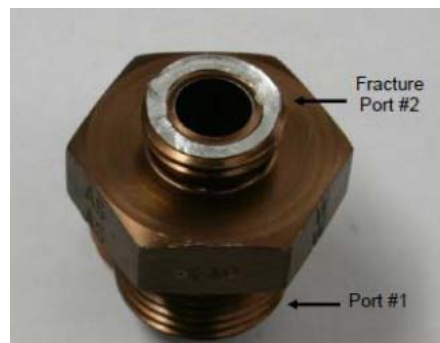
Bell Helicopter has been informed of an incident where a Model 412 EP had made a precautionary landing due to loss of hydraulic pressure of the number 1 hydraulic system. The investigation revealed that the loss of hydraulic pressure was due to excessive tightening of the hose coupling nut resulting in fracture of the aluminum fitting at the outlet port of the hydraulic pump.

This Information letter emphasizes the importance of proper torque application on fluid lines coupling nut and fittings. For proper torque application, refer to the BHT-ALL-SPM Tables 2-9 and 2-10. As noted in the Table 2-10, for torque application on flareless fitting nuts, the "Nut Turn Method" is recommended when standard open end wrenches are used. This method recommends tightening the nut 1/6 to 1/3 turn (1 to 2 Hex flats) past the point of sharp torque rise.

After proper torque application, if fluid leak is observed, the line and mating fitting should be inspected for possible damage and wear. Excessive tightening of fluid line coupling nut and fitting to achieve leak free condition may result in cracking or fracture of fluid fittings.
