OPERATION SAFETY NOTICE

205-14-46
212-14-50
412-14-41
412CF-14-13

SUBJECT: FULL FLOW DEBRIS MONITOR INSTALLATION

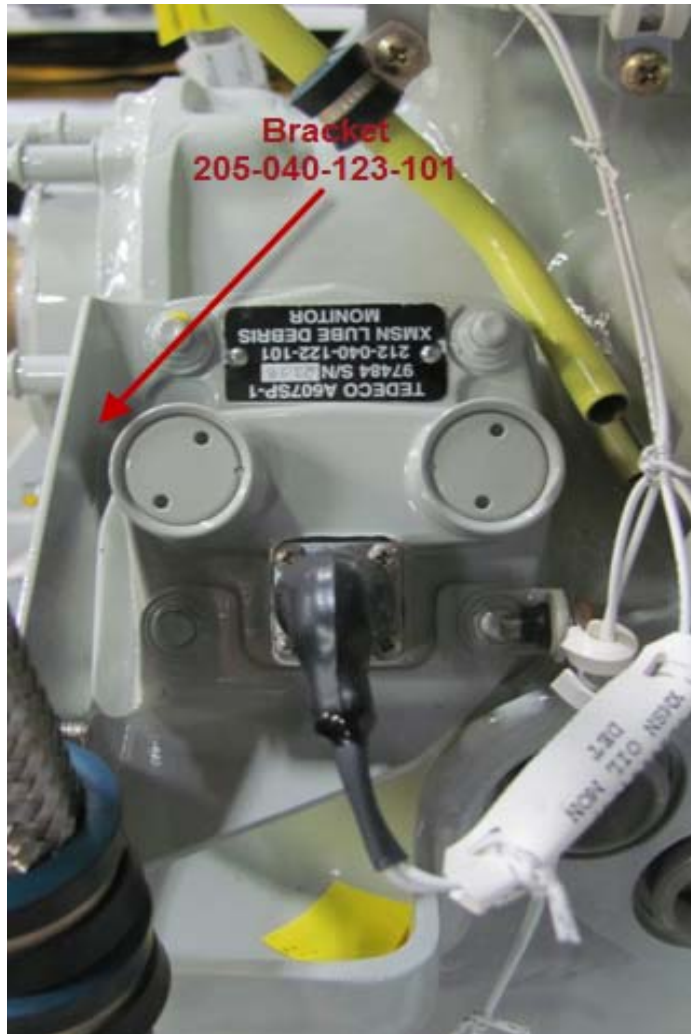
Figure 1 - Full Flow Debris Monitor Correct Installation

Bell Helicopter has recently investigated two different situations where the transmission full flow debris monitor was incorrectly installed resulting in attaching stud failure and subsequent loss of transmission oil. When not properly installed, the bracket 205-040-123-101 will not sit flat on the full flow debris monitor flange resulting in loss of torque of the attaching hardware and possible failure of the studs.

The purpose of this OSN is to remind operators of the correct installation procedure of the full flow debris monitor as described in the Maintenance Manual, Chapter 63 and to emphasize the importance of the proper torque application. The electrical connector shall be at the bottom and the data plate at the top, as shown in the attached figure.
