Rub Your Bird the Right Way

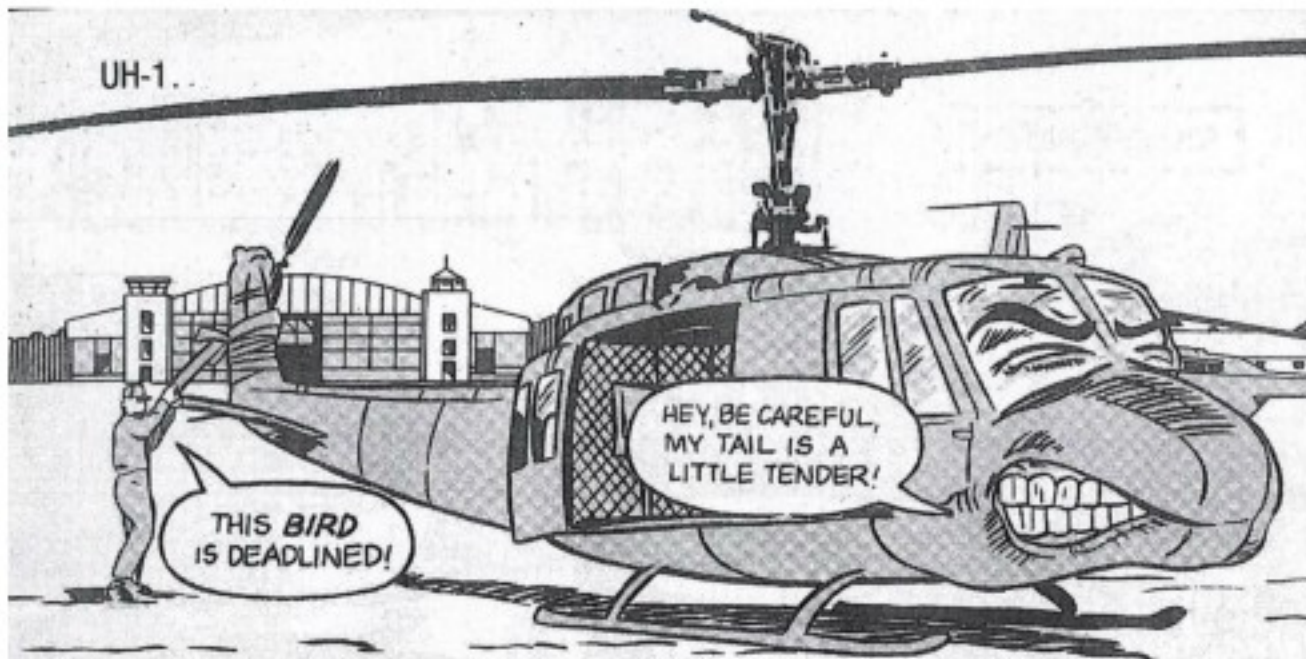
Keep your bird's tailboom skin off the bumpy road to ruin by replacing missing rubber bumpers on access doors. When bumpers, NSN 5340-01-054-1588, come off, engine vibration does a number on the Huey's soft aluminum skin. The area where the bumper should be can even wear right into the skin it's touching! That'll send the aircraft to support.
