So your Huey has the new 1-piece tail rotor crosshead bearing, which takes the place of the old 2-piece bearing.

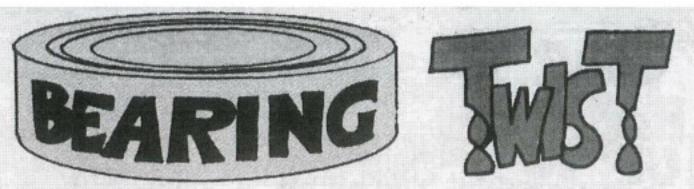
The old bearing could be Murphied. Not so with the new one, which

works installed either way.

But—if you use a little force during removal or installation, the inner race will pop . . . happens!

To help keep the bearing in 1 piece, use only finger pressure on the inner race during removal or installation.

If the bearing separates, tho, just clean the parts thoroughly and reassemble the bearing. It may be necessary to stick the balls in place with a dab of grease, MIL-G-25537.
