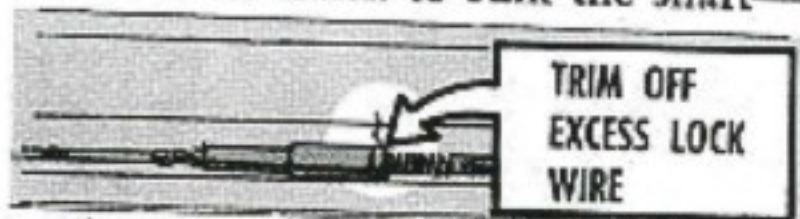
Another thing while we're talking about the drive shaft—be sure you have the excess lock wire at the quick disconnect (No. 4 shaft) cut off and the remaining tail bent away from the shaft. Otherwise, movement of the rotor cable with the lock wire sticking out can scratch the drive shaft for real. It doesn't take much to ruin the shaft—

you're only allowed a 0.002 inch scratch . . . Chapter 2, Section VI, page 6-3, of your maintenance manual.
