Cushion for Cover

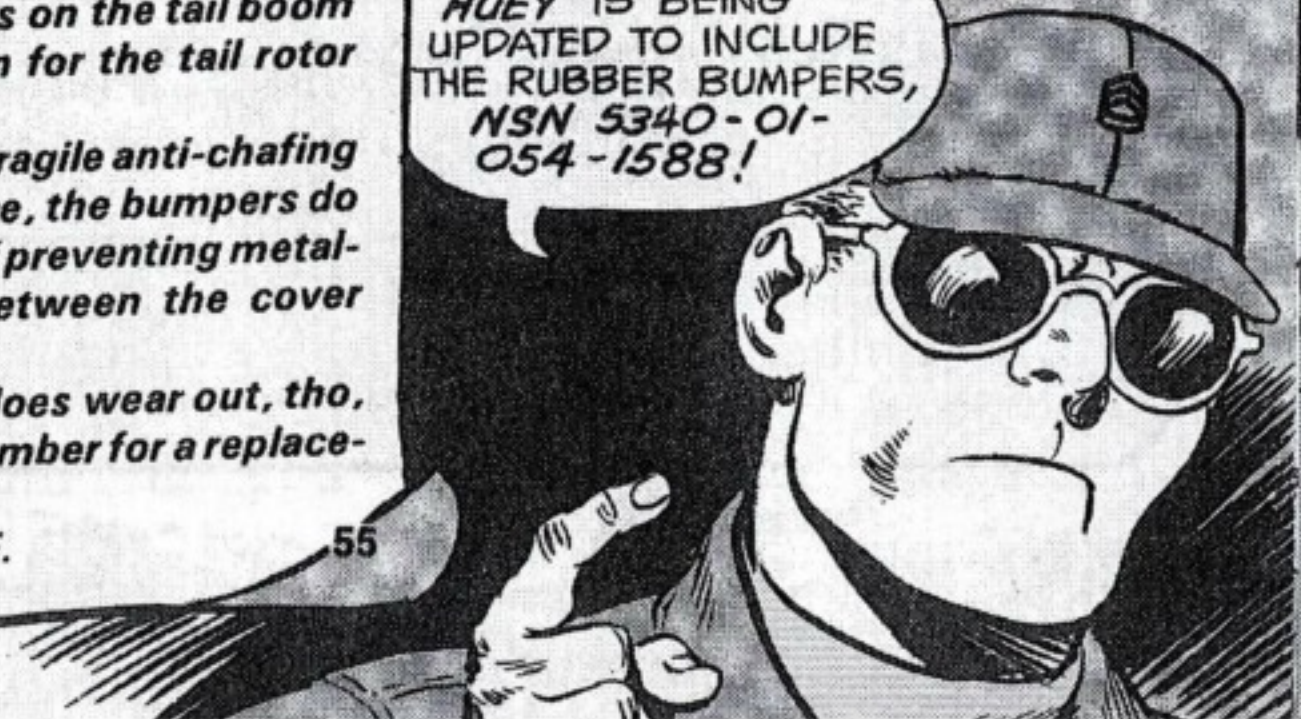
Some of our UH-1's are coming thru with rubber bumpers on the tail boom to provide a cushion for the tail rotor drive shaft cover.

Compared to the fragile anti-chafing tape we normally use, the bumpers do a much better job of preventing metal-to-metal contact between the cover and tail boom.

TM 55-1520-210-23P ON THE HUEY IS BEING UPDATED TO INCLUDE THE RUBBER BUMPERS, NSN 5340-01-054-1588!
