# UH-1H Elevator Removal

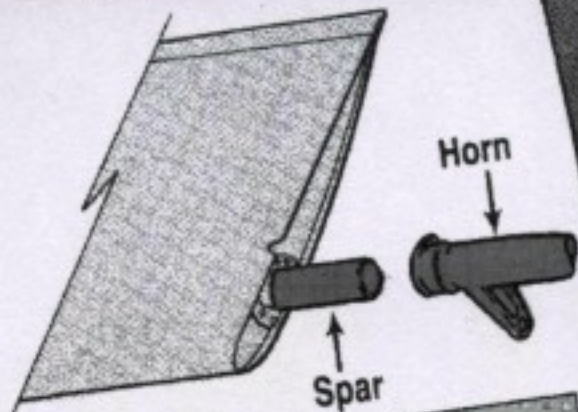
The problem is the corrosion preventive compound (CPC) has hardened and made pulling the spar from the horn a very tough job. Many mechanics try to pry them apart and then damage the horn and spar.

Apply heat to the horn with a heat gun to separate spar from horn.

The solution is to soften the CPC. Just open the elevator horn access panel and apply heat to the horn with a heat gun. The CPC will soften and make removal of the elevator easy.
