UH-1 Avionics...

## Seal Antenna Screws

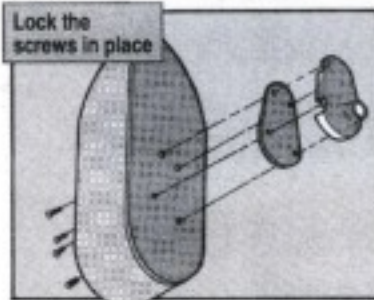
The 4 screws holding the #1 FM antenna to the cover of the coupler on your Huey tail fin can work loose and fall out or break.

Without the screws, the antenna flies off and into the tail rotor. At the very least you'll have a damaged rotor. At the worst, well...

The screws come loose because nothing locks them in place.

So, take off the coupler cover and check the screws. If they're loose, lock 'em in place with sealing compound, NSN 8030-00-935-7100. Replace any missing screw, NSN 5305-00-727-8832.

Good advice is that at the next scheduled service, remove the screws, apply a light coating of sealant, then put them back in. Make a note to use sealing compound every time you tighten or replace an antenna screw.
