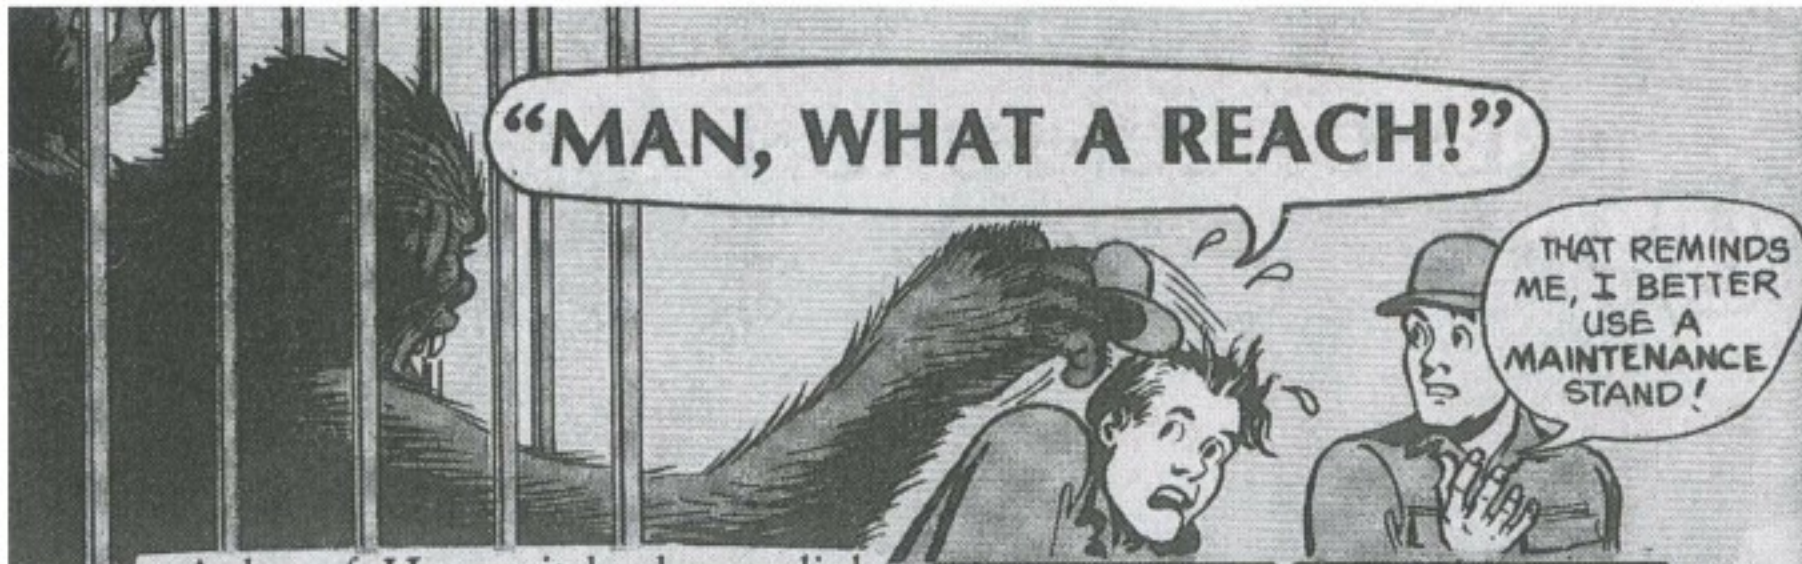
A lot of Huey pitch change link universal bearings bite the dust at overhaul just because they're not completely lubed with the grease gun during PM Periodics.

One side of the bearing winds up smooth as silk—the other side rough as a cob.

'Course, it's easy to reach the lower grease fitting with your needle nose adapter . . . not so with the upper grease fitting.

So you're not 7 feet tall with the reach of a gorilla! Go up there, anyway, using a maintenance stand if necessary.

Purge-lube both fittings until you see the old grease coming out of the bearing, and wipe off the excess. Then, a lot of expensive bearings won't have to be replaced.
