The foam rubber barrier filters were removed from your Huey when MWO 55-1520-210-30/17 (Jun 68) came out with the engine particle separator and inlet filters. The foam rubber filters were taken out because the ice detector was removed.

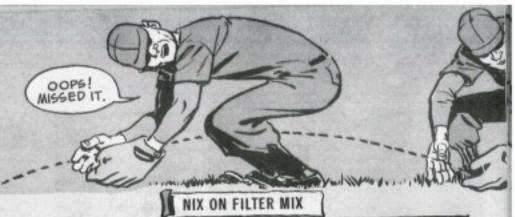
Trouble is, some of the old foam filters are being used along with the new 14-mesh filters. The foam filters collect moisture which can freeze in cold weather and choke off air to the engine inlet.

Rubber filters are out when operating in cold weather.
