CHANGE THE GASKET ALSO

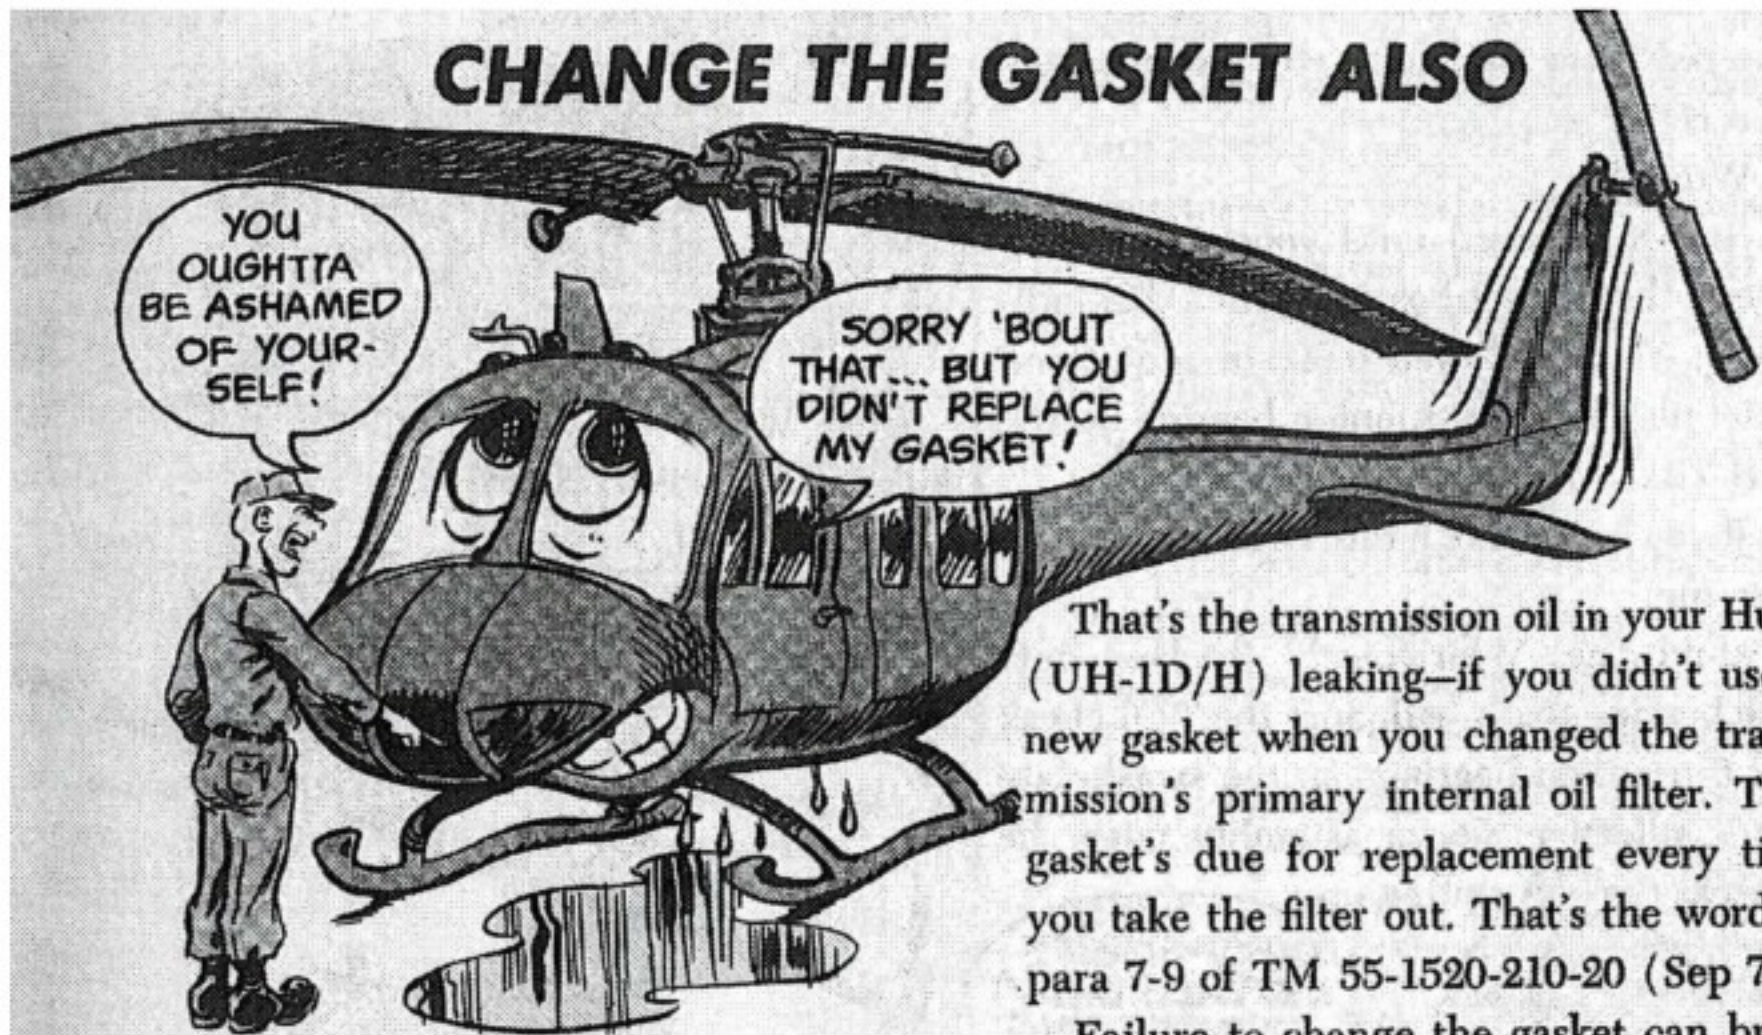
Drip . . . drip . . . drip.
No, that's not a leaky water faucet.

That's the transmission oil in your Huey (UH-1D/H) leaking—if you didn't use a new gasket when you changed the transmission's primary internal oil filter. That gasket's due for replacement every time you take the filter out. That's the word in para 7-9 of TM 55-1520-210-20 (Sep 71).

Failure to change the gasket can bring about bad things like emergency landings, due to loss of oil.
